SELLERS TREYBAL STRUCTURAL ENGINEERS PC
277 Blair Park Rd, Suite 220
Williston, VT 05495
802.497.1174 | www.STS-Engineers.com

November 30, 2018

Re: Fairfax Community Center - Structural Evaluation

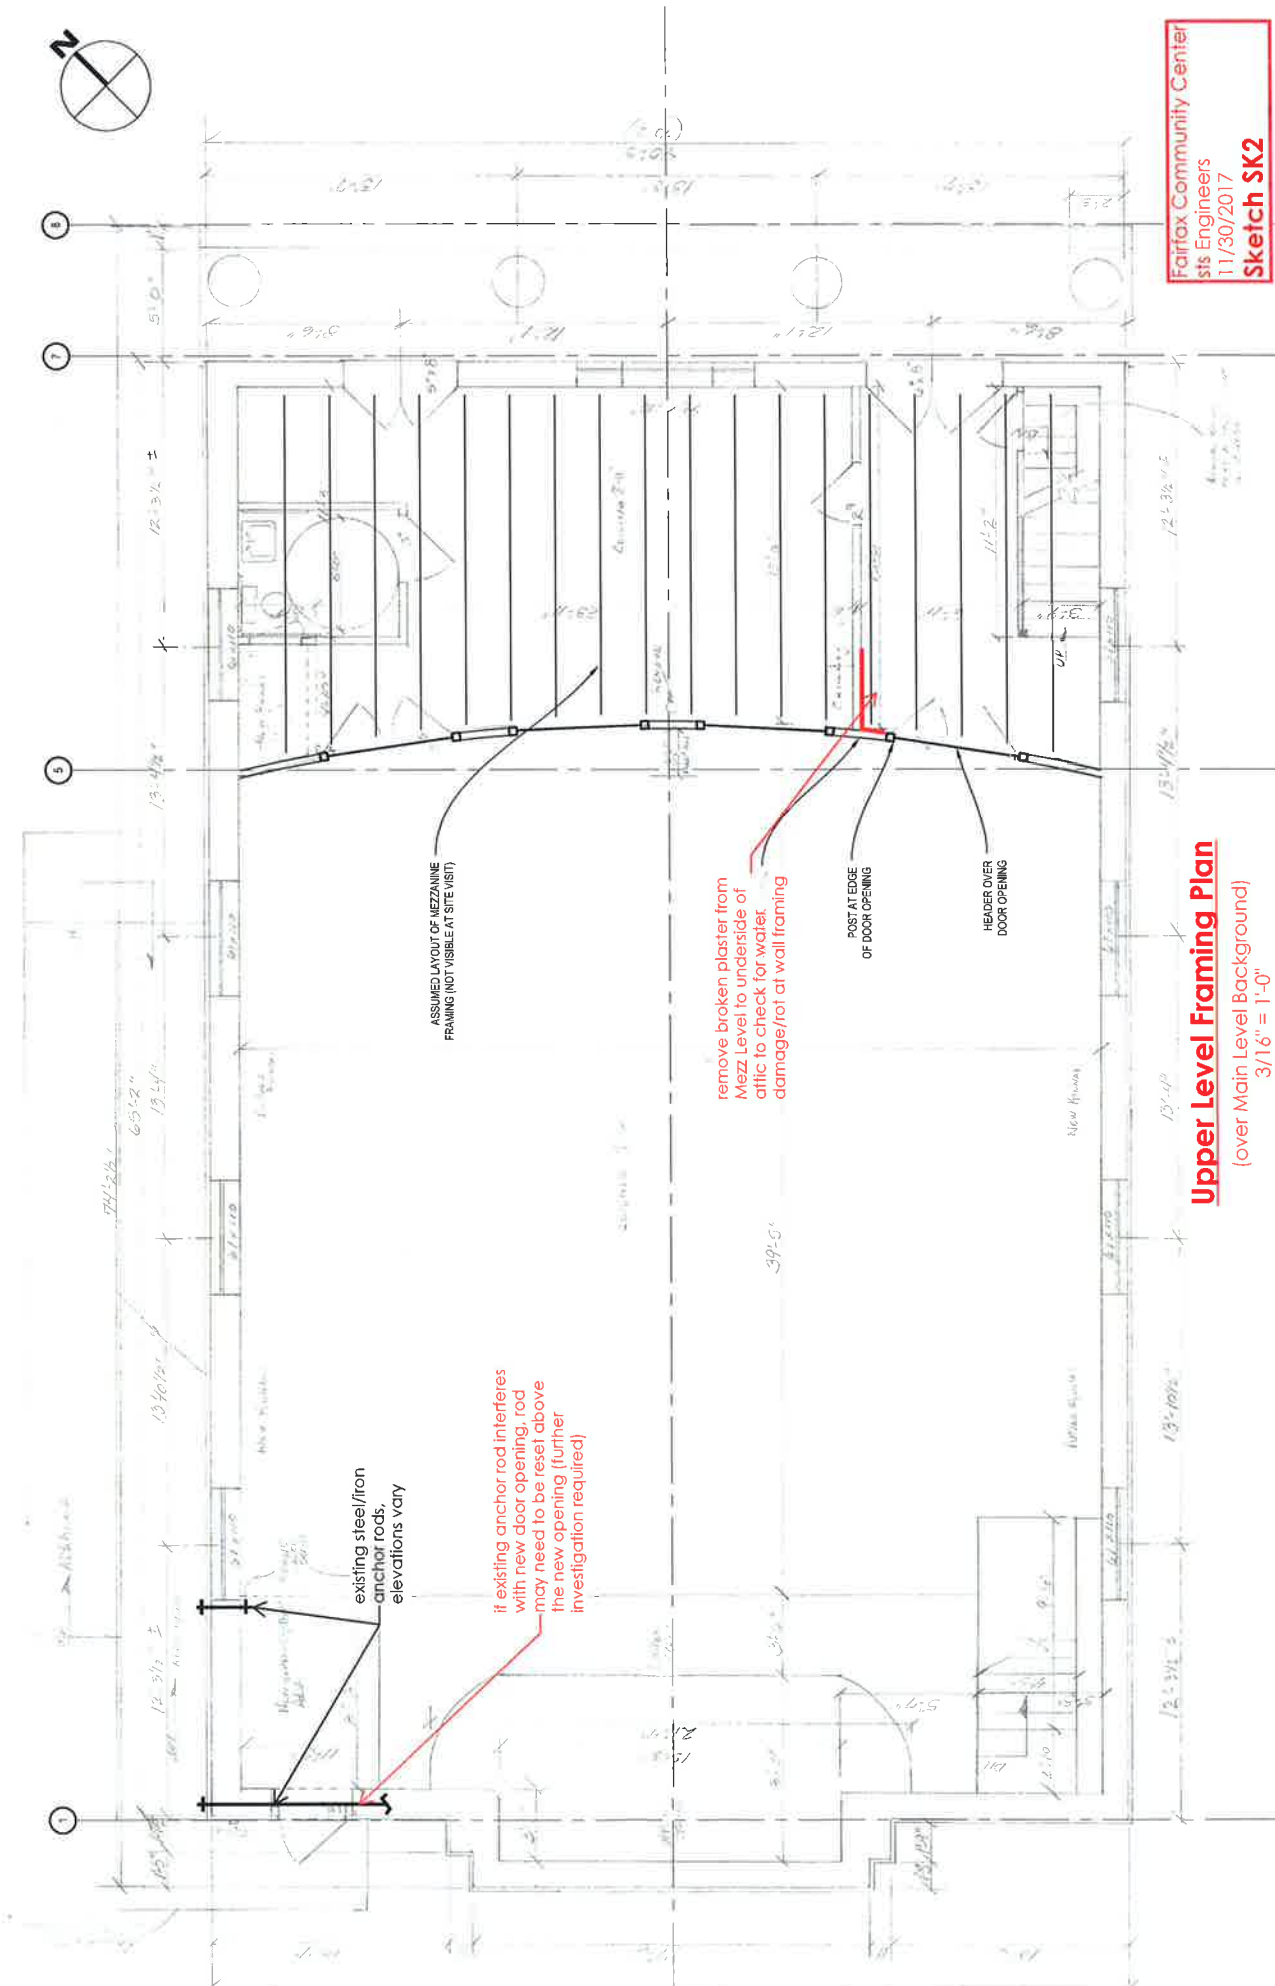
Upper Level Framing Plan
 (over Main Level Background)
 3/16" = 1'-0"

The upper level framing was not visible to determine the sizes or even the layout of the existing framing. Drawing SK2 shows the presumed layout of the framing, spanning from the exterior wall to the curved interior wall, but this remains unconfirmed.

The architectural finishes above and below the upper level framing show no signs of distress (such as cracking, buckling, crumbling) that would indicate structural distress at the Upper Level joists. The floor is a little bouncy under the "jump test", but nothing out-of-the-ordinary. Based on this assessment, it is reasonable to assume the existing floor framing has been performing adequately for the existing loads. For planning purposes, it would be reasonable to use this space for occupancies with up to a 50 psf live load, which includes offices and classrooms, but precludes public assembly or storage use.

- Framing is presumed OK for 50 psf live load, appropriate for office or classroom use.
- For higher live load (such as public assembly or storage), probes are needed before the capacity of the existing framing can be verified.

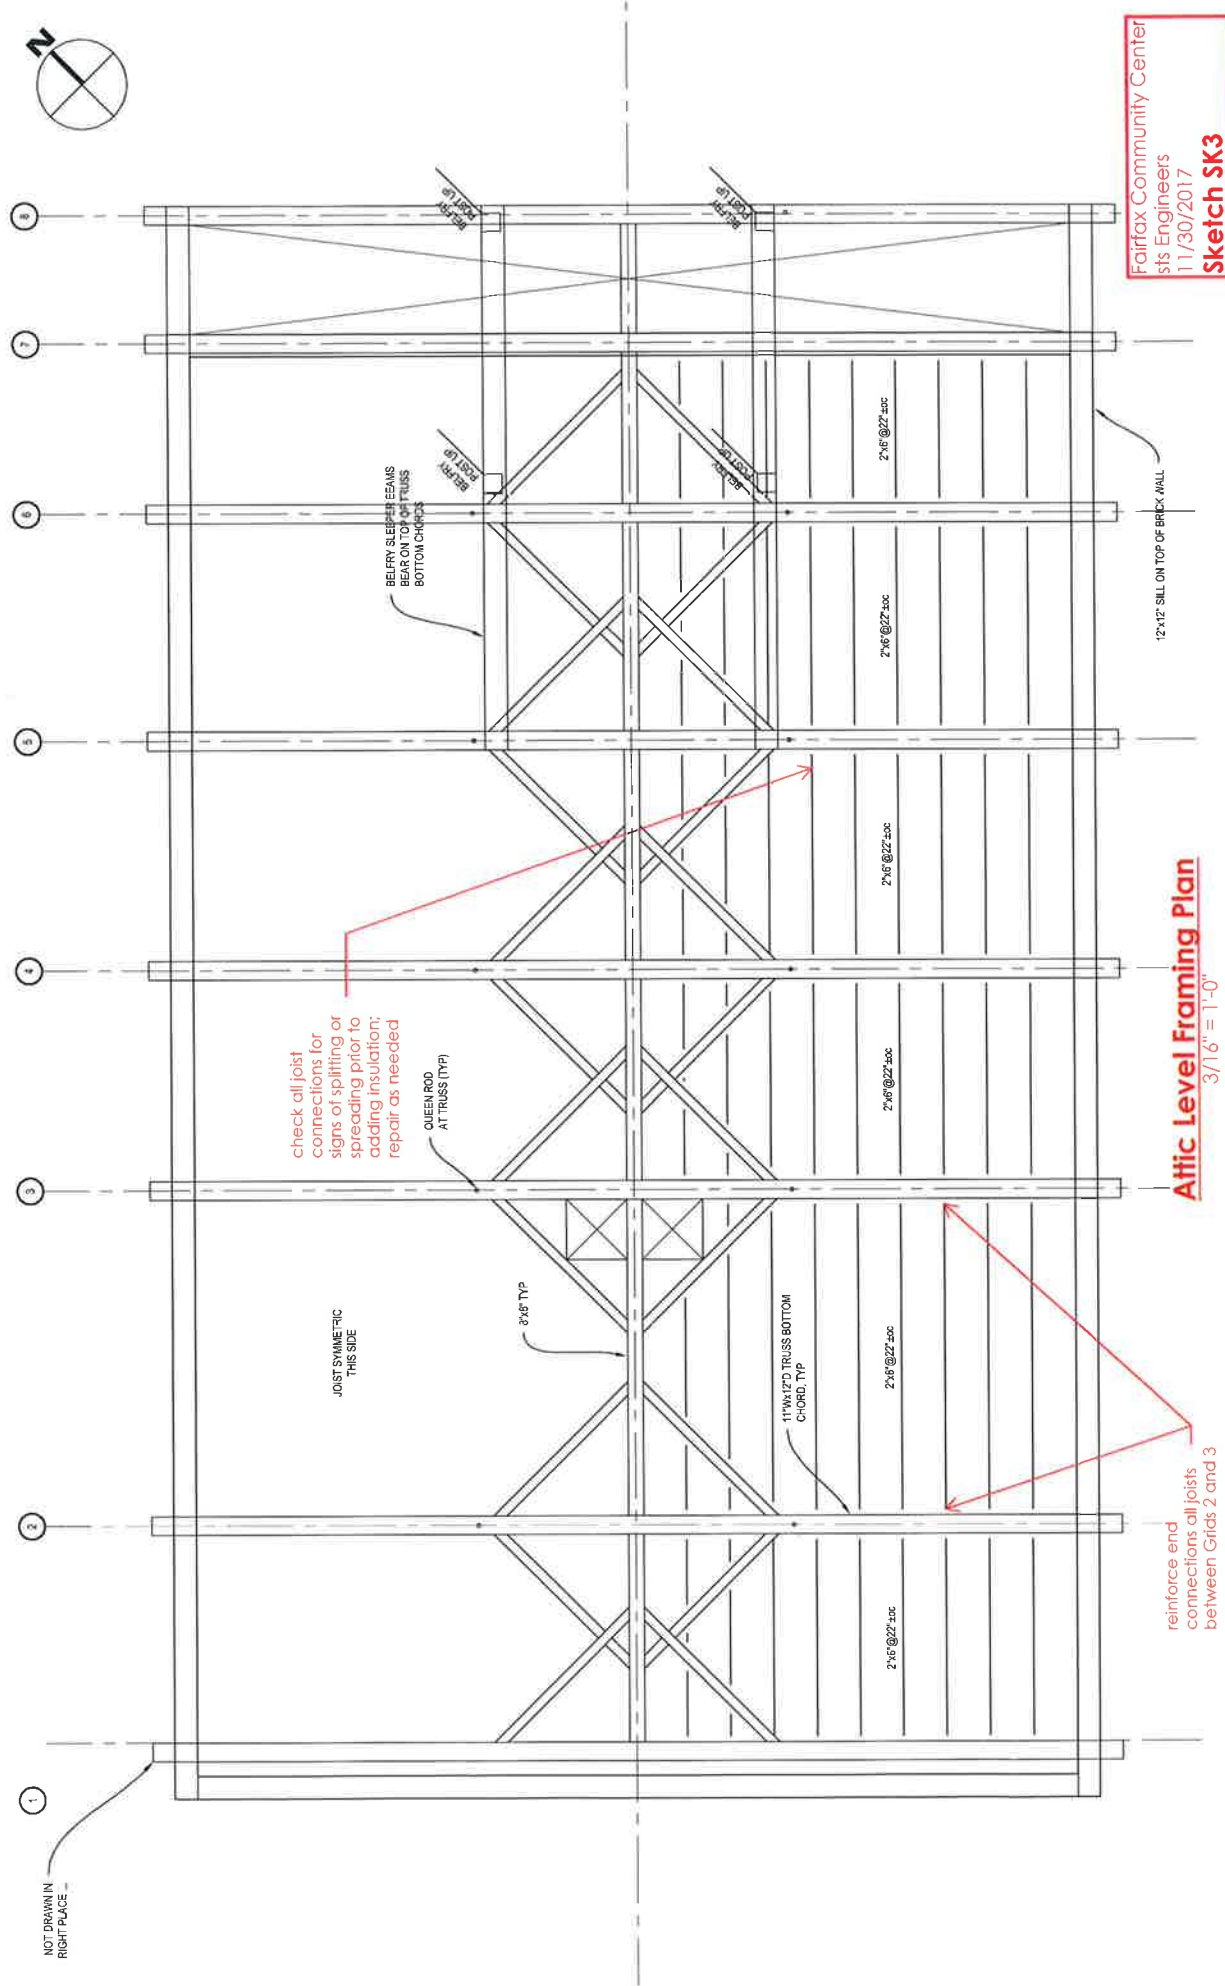
Attic Level Framing Plan
3/16" = 1'-0"

The general layout of the existing attic level framing is shown in drawings SK-3. The truss bottom chords run from exterior wall to exterior wall. The attic joists span between the truss chords, and are notched into them. The attic joists are typically 2"x6" at 24" on center, except for the longer span between Grids 2 and 3 where the joists are 2"x8". The plaster ceiling of the sanctuary is fastened to the bottom of the joists, there is batt insulation in between most of the joists, and no walking surface on top of the joists.

When viewed from the sanctuary below, the plaster ceiling appears relatively level with some minor hairline cracking of the plaster. The cracking pattern in the plaster ceiling does not indicate any performance problems with the existing attic framing under the existing (non-storage) loading.

The rafters were checked for a 10 psf live load, which corresponds to "maintenance access only" and is not sufficient for attic storage loading. At this maintenance-level live load, the existing joists were found to be adequately sized for bending over the span, but inadequate by code for shear at the ends where the joists are notched into the supporting members. The ceiling joists are typically notched down to 2" high by 2" wide tenons, which pocket into the truss bottom chords.

- Do not use the attic for storage.
- Check all existing attic joist end connections before increasing the depth of the insulation. Reinforce any split or dubious connections at the typical joists, and reinforce all notched connections at the longer-span joists between Grids 2 and 3.
- When adding insulation, leave the truss heel joints exposed to view and well ventilated.
- Add walkways for future inspection access.

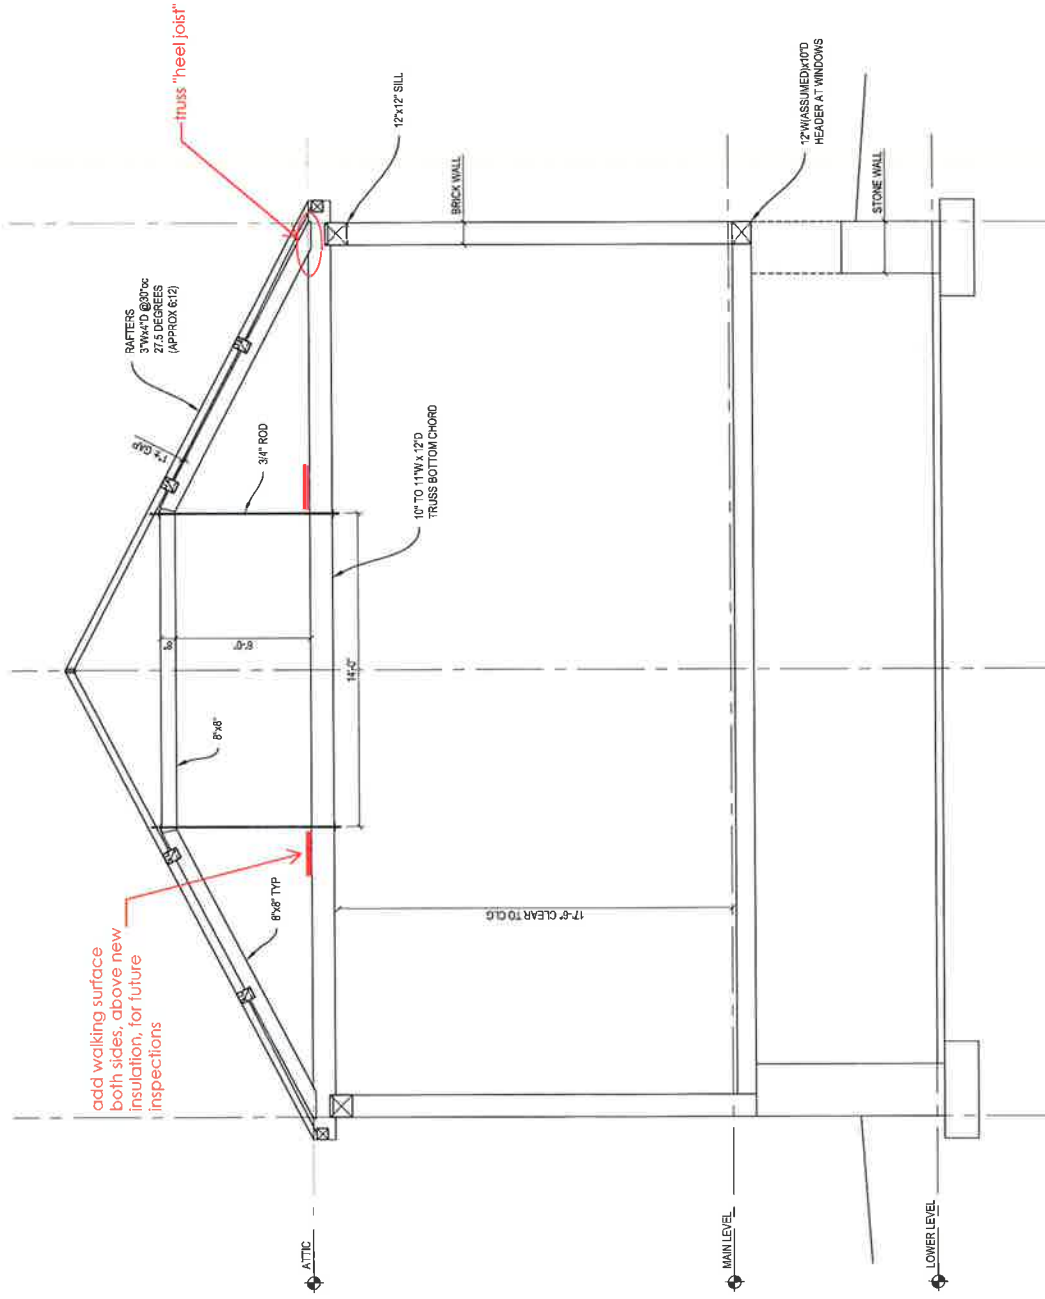
Section
3/16" = 1'-0"

The roof trusses are shown in cross section in sketch SK5. The truss's principle rafters and horizontal top straining beam are sawn 8"x8". The truss bottom chord, located at the attic framing level, is a hewn beam approximately 11" wide by 12" deep. The bottom chord is hung from the intersection of rafter and framing beam with a 3/4" rod at each side. The roof trusses appear to be in excellent condition with no signs of structural distress. In particular, there is no sign of movement or splitting at the critical heel joints where the rafters bear against the top of the top chord. These are joints that are prone to structural failures, particularly if leaking water has accumulated inside the joint. Load rating calculations have not been performed for the roof trusses, as the proposed project will not increase roof loads and the trusses appear to be performing satisfactorily.

The 3"x4" rafters all appeared to be in sound condition with no signs of structural distress, aside from one rafter split at its notched end that is already adequately shored. Load rating calculations show that the rafters are suitably sized for anticipated snow loads.

- Replace or reinforce the four grossly undersized roof purlins between Grids 2 and 3. Until such time as this can be done, reduce risk during periods of unusually high snow load

accumulation on the roof by "tamping" off the snow in this bay from within the attic space, or by not using the back end of the building until the snow slides off the roof.

- Add the purlins and their unusual splice connections to the annual maintenance list, to monitor for any signs of changes such as splitting or increased deflections.
- Replace or reinforce the poorly repaired purlin at the downhill side of the chimney between Grids 2 and 3.
